**Local Government Energy Program
Energy audit report**

***Union County Educational Services Commission (UCESC)
Crossroads School & Administrative Offices
45 Cardinal Dr
Westfield, NJ 07090***

Project Number: LGEA17

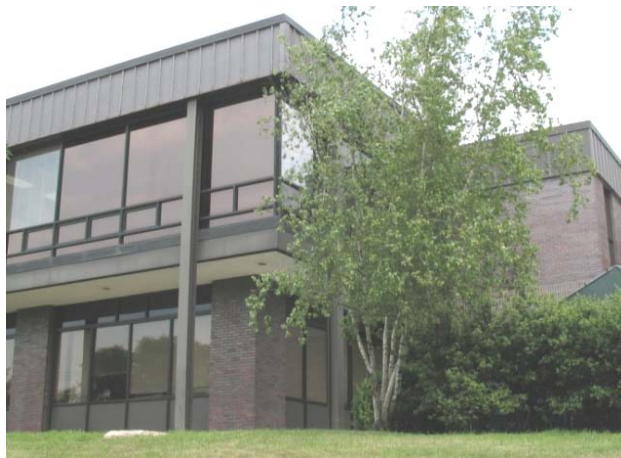
Overall, exterior and interior wall finishes of the envelope were found to be in age-appropriate, good condition with no major signs of unusual water or air leakage.

Typical Partial Exterior Elevation

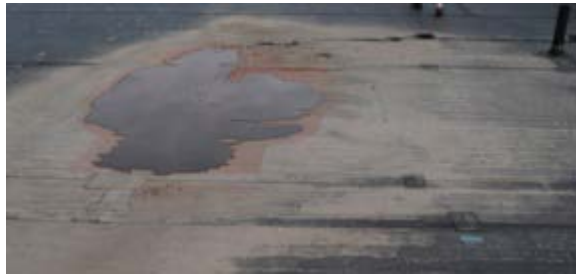
A/C Condensate Water Pooling on Dry Day

- Diverting AC condensate lines on roof – The AC equipment is currently situated near the center of the roof with no nearby roof drains. The condensate lines of the rooftop equipment are allowed to drip freely on the roof surface. There are signs of standing water on the roof surface that have begun to penetrate the new roof surface and have caused leaks in the roof cavity. To avoid further maintenance issues, these condensate lines should be diverted away from the equipment towards the nearest roof drain.

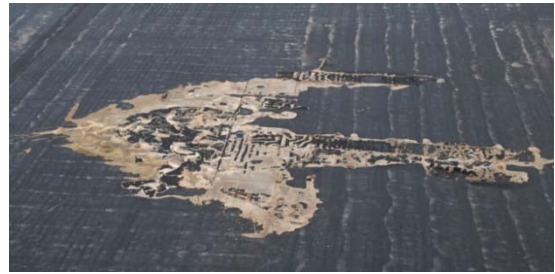
Apparent Spillage Area

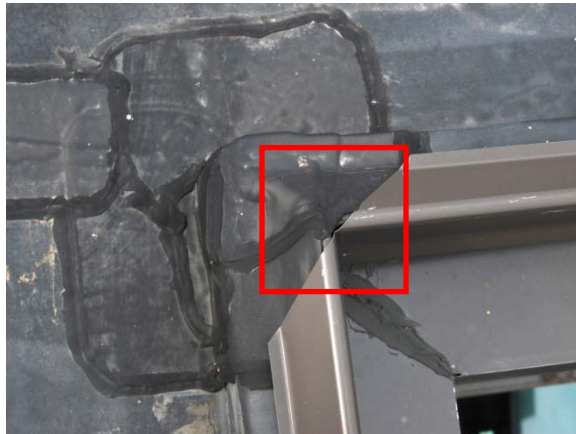
Aluminum Corner Flashing/ EPDM Detail

- Repair aluminum flashing/EPDM detail at corners of roof surface – The roof was installed with the corner flashing cut to improper lengths, allowing a gap to exist between the EPDM roof surface and the aluminum corner flashing. This gap can allow water to penetrate the roof surface and work its way through the roof cavity. The original roofing contractor should fix the corner details as well as address any standing water issues.

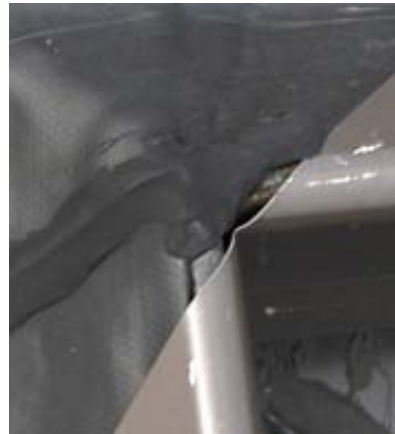
The flat roof of the building was recently replaced with a dark colored EPDM rubber membrane. The roof surface appeared to be in fair-good condition overall except in some inside corners, lack of attention to detail by the roofing installer was detected. Aluminum flashing in those areas was cut too short, potentially allowing water to enter either the interior side of the steel structure or the parapet wall cavity. There were also signs of water pooling from the AC condensate lines on the mechanical equipment visible, which is common. However, due to the lack of a nearby roof drain, SWA recommends diverting condensate lines to a dedicated drain to avoid potential roof leaks due to pooling. A leak, evident in ceiling tiles on the second floor was mentioned to the inspectors and could possibly be traced back to the mentioned pooling or nearby apparent spillage area. SWA recommends the original roofing contractor to fix the above mentioned corner issues and at the same time investigate the existing roof leak.

Close-Up View Shows Leak

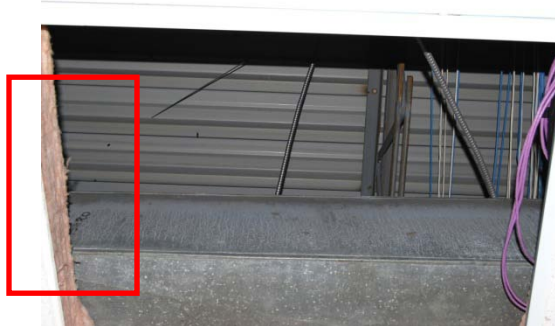
Additional roof/ floor related issues: SWA observed 3.5” fiberglass batt insulation located in the plenum area of the building, positioned on top of the second floor dropped ceiling. The building’s exterior envelope projection of the second floor over the ground floor has a potential for creating cold spots on the overhanging second floor area. A separate envelope inspection should be conducted during cooler months. SWA suggests basing further insulation related improvement discussions on the outcome of those future findings.

Evidence of existing 3-1/2" Fiberglass Batt ceiling Insulation

- Increase level of insulation at roof– As noted previously, insulation levels should be increased in at the roof. This measure is recommended but is not cost-effective due to the fact that the roof surface was recently replaced. When the roof surface was replaced, minimal levels of rigid insulation were installed underneath the black rubber EPDM surface. These minimal levels of rigid insulation are tapered and are only meant for forming a drainage plane on the roof surface. Since the roof cavity contains ductwork that should be kept within the conditioned building envelope shell, the roof surface is the best area to install additional insulation. Alternatively, polyurethane spray insulation could be applied to the underside of the roof surface but may become an issue with building and fire codes. In addition to insulation added to the ceiling of the roof cavity, the side walls would also have to be insulated to fully isolate the roof cavity.

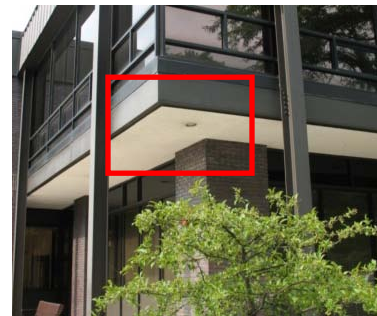
Exposed Second Floor Area

Second story cantilever - The 2nd story of the building is cantilevered over the 1st floor by approximately 4 feet. According to building drawings, the insulation located in the floor of the cantilevered space is minimal. The cantilevered space relies mostly on 1" insulated metal soffit to keep cold air out of the building. In addition, the steel beams that are exposed to the outside elements are connected directly to the steel beams that form the major infrastructure of the building. The contact points between the outside beams and the inside beams are not insulated, thus forming a thermal bridge for heat to travel into and out of the building. SWA recommends if the cantilevered areas are accessible for any type of renovation, insulation should be added, approximately R-30. Insulation should be in contact with the 2nd floor in order to reduce heating and cooling losses.

- Increase level of insulation at cantilevered second floor – As noted previously, the second floor is cantilevered out over the first floor by approximately 4 feet. According to building drawings, this area is poorly insulated and consists of only a 1” insulated metal soffit. The current amount of insulation allows for heat to transfer both in and out of the building, in the direction of the coldest surface. This measure will not be cost-effective due to the amount of work required to access the specific area. SWA recommends this insulation is increased as part of a capital improvement plan, if any improvements require accessing the same cantilevered area.

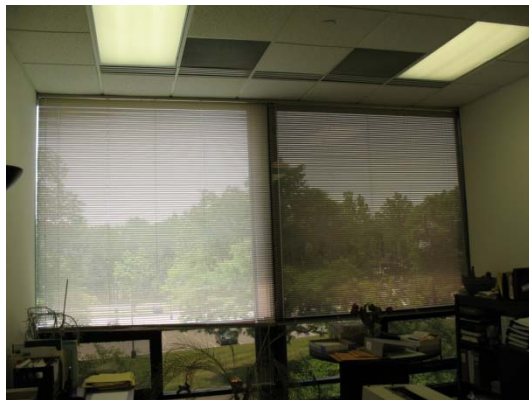
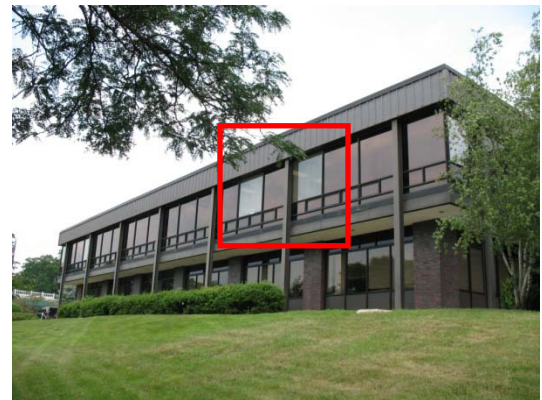
The windows on the second floor are the original single pane metal framed windows. While the windows appeared to be in fair-good condition with no obvious penetrations or missing caulking around the frame, metal framed windows are inefficient as they do not allow for a thermal break; therefore there is excessive heating / cooling loss due to the metal frames. Furthermore, single pane windows are inefficient and contribute to excessive heating and cooling loss. Some windows have been fitted with a reflective film coating that is ineffective at blocking solar radiation for single pane models. In addition, it was obvious that some windows were missing the reflective film.

Single Pane Windows on 2nd floor – left window missing film Some 2nd Floor Windows Missing Window Film

As mentioned above in Windows Section 2.3.4, the second floor windows are original to the building. These windows are metal-framed with no thermal break and consist of single-paned glass with no low-e coating. There are two major reasons that temperatures are unevenly distributed across the second floor of this building; insulation levels and windows. SWA recommends that the windows on the second story are replaced with metal-framed windows with a thermal break. These windows should contain double-paned, argon-filled glass that also contains a low-e coating. Window replacement can alleviate most of the temperature distribution problems, but increasing levels should still be considered as part of a capital improvement plan. Replacing the windows does not show a positive return-on-investment but is a necessary measure to be implemented for energy efficiency and to realize further energy savings with other HVAC related measures. Replacing windows is also necessary to realize true savings with ECM#5 that deals with reconfiguring controls.

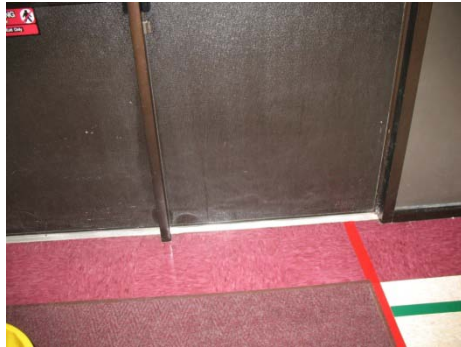
Double doors in good condition

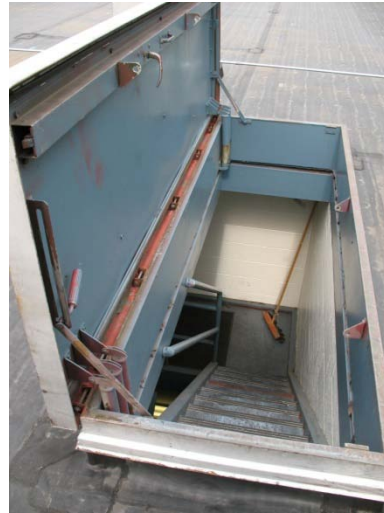
Roof access – metal-gasket door

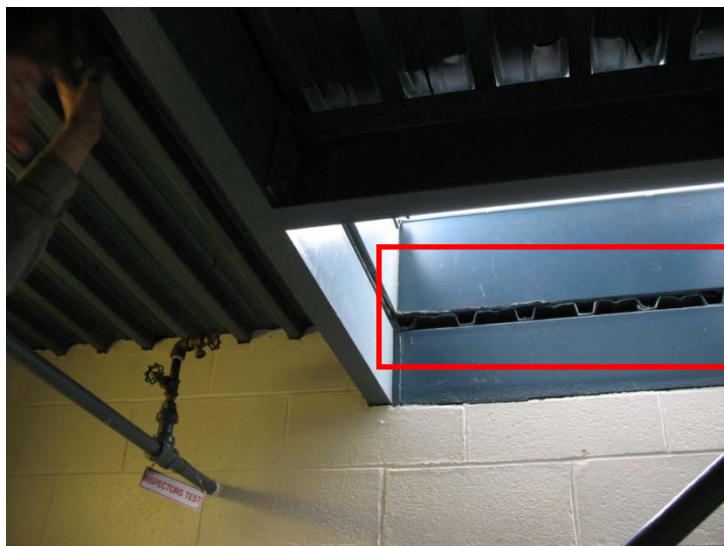
The Crossroads School and UCESC administrative office building appeared to have relatively tight building envelope. Regular maintenance should be performed to maintain sufficient seals in order to keep conditioned air from leaking outside the building, such as weather-stripping doors and caulking around window framing. Other penetrations should be sealed with foam or caulk, such as plumbing, HVAC penetrations, and wire penetrations throughout the building. The image below shows the metal door framing to the roof with obvious penetrations between the ceiling and roof. Any trapped heated or cooled air leaks into the building due to this opening in the building envelope.

Penetrations found below the roof deck leading to heating/cooling losses

- Repair penetrations between the ceiling and the roof – Currently, as addressed in Section 2.3.6, there are penetrations formed from the corrugated metal roof material between the roof and the ceiling. These exposed areas allow heated or cooled air to enter the building shell and eventually leak into the building. Spray foam or caulk should be added to form an air barrier as well as a thermal barrier at this specific junction.

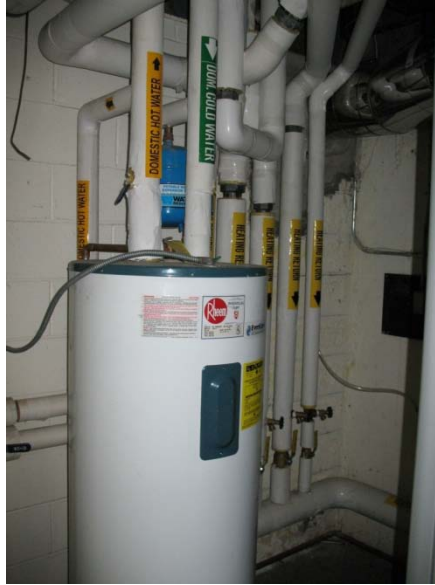
Domestic Hot Water for the building is provided by a Rheem electric hot water heater with a maximum input of 6,000W and a storage capacity of 80 gallons. The hot water heater was manufactured in 2004 and has an Energy Factor of 0.86. The Domestic Hot Water supply set point was currently set at 128°F. The system contains hot water recirculation with a Lawler electronic thermostatic mixing valve.

Electric Water Heater

It is not cost-effective to replace the existing water heating equipment with higher efficiency equipment. However, higher efficiency water heating equipment will save energy and should be strongly considered upon replacement of the equipment. Energy saving appliances bearing the ENERGY STAR label should be selected to ensure efficiency performance. Incentives may be available to offset any added costs for the installed equipment.
