Executive Summary

This report covers the investigation of the Enertech E44A wind turbine incident at the Knoeller site. The objectives of the investigation were to determine the cause of the turbine's failure and whether it was an isolated incident or a potential problem that would reoccur in existing and new E44A wind turbines. This report provides background information and a description of the events, actions, documentation, and assessment process. In addition, the report describes the site evaluation and design and testing assessments and provides conclusions and recommendations.

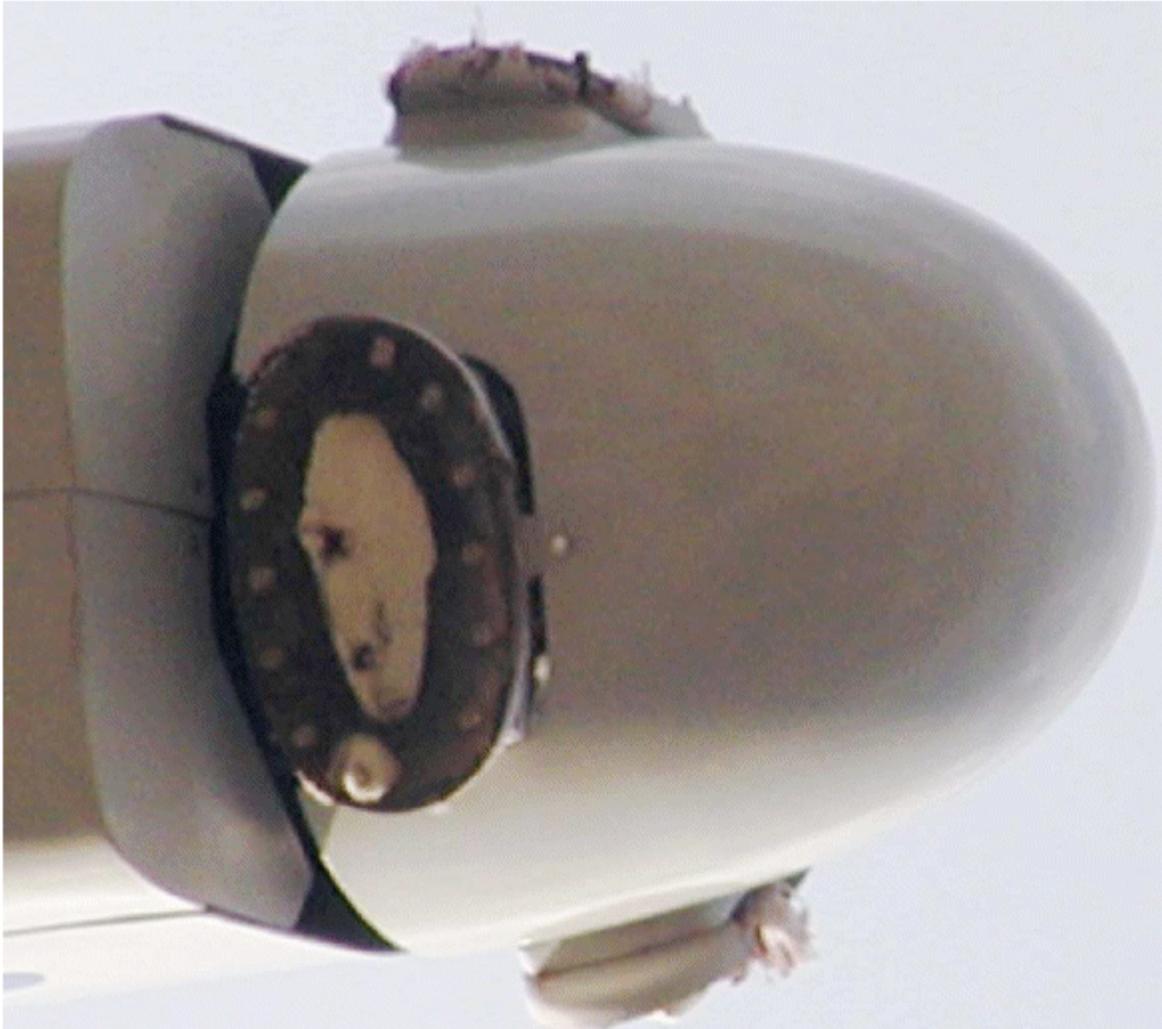
Figure 1. The Knoeller site turbine hub after the blades had separated

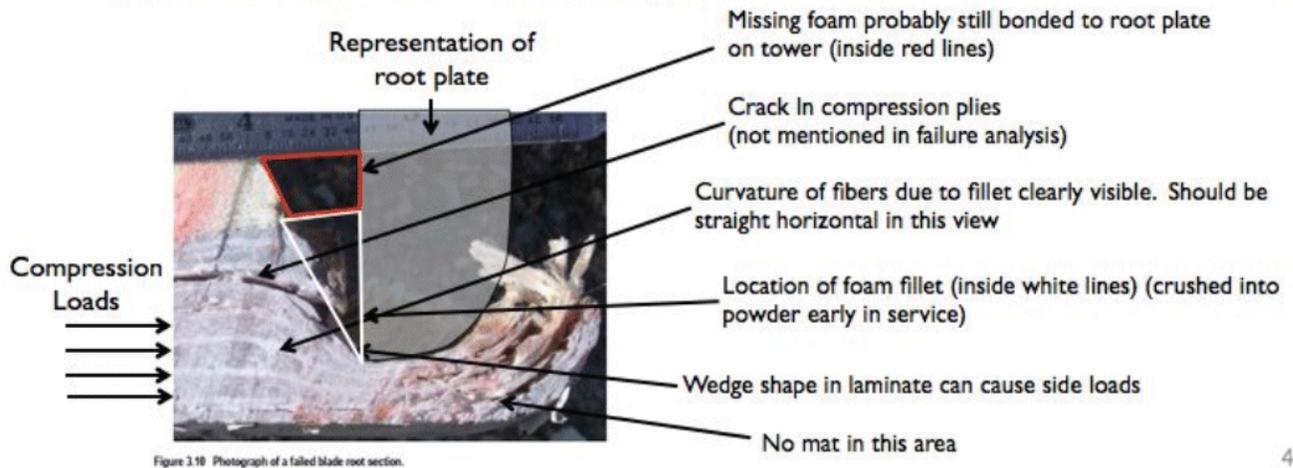
During the January 17, 2012, design review, Enertech stated that design calculations of the blade structure were made; however, no documentation of the analysis was provided for review. In addition, Enertech provided justification for the theory that the presence of the foam fillet was the root cause of field failures because of the deviation in the intended load path. [Figure 7](#) shows a description provided by Enertech on how the presence of the foam fillet was the sole source of the blade failures.

Figure 7. Enertech assumptions of failure mechanism

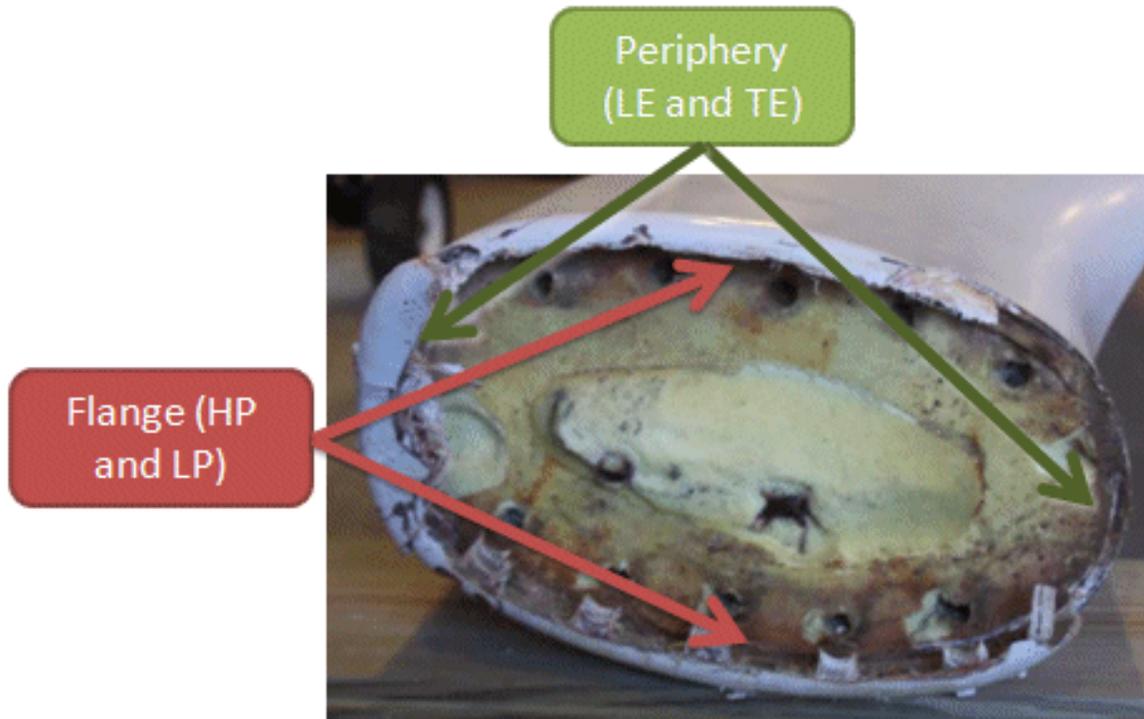
Both the Jackson and Wetzel Engineering reports contain detailed forensic assessments. All three unbolstered blades inspected at the Knoeller site had the steel root plate and fasteners torn away. The blade root laminate showed a consistent line of laminate fracture near the edge of the steel plate and the laminate surrounding the fasteners was torn away during the failure event. [Figure 16](#) shows a photograph of the failure that is representative of all three blades. In addition, two areas commonly referred to in the assessment—the flange and periphery—are identified.

Figure 16. A failed blade root section

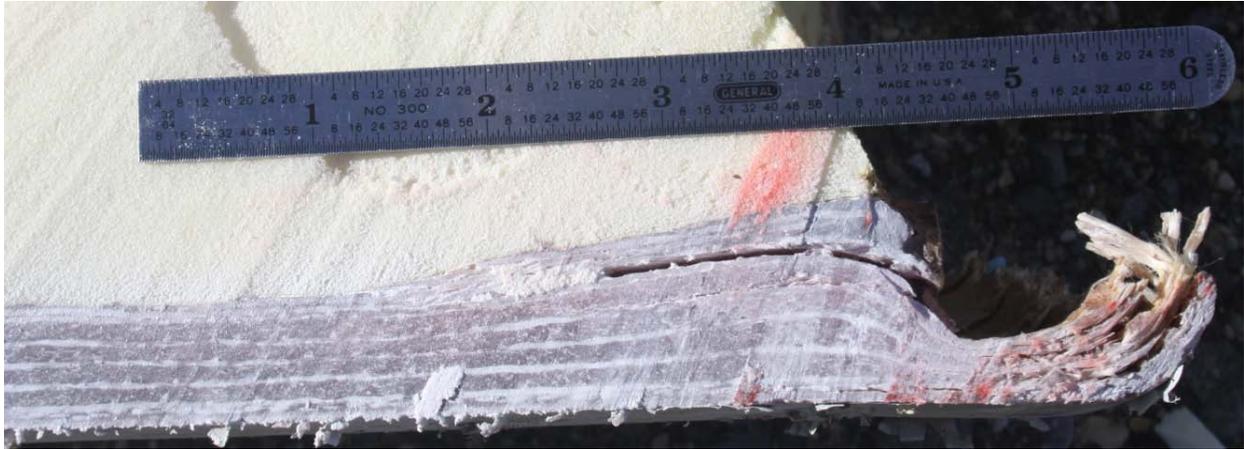
As shown in [Figure 17](#), a section cut was made in the low-pressure flange to reveal a cross section of the laminate in the root-to-tip plane. The steel root plate is not shown (still attached to the hub).

Figure 17. Root-to-tip section of low-pressure skin in the root area

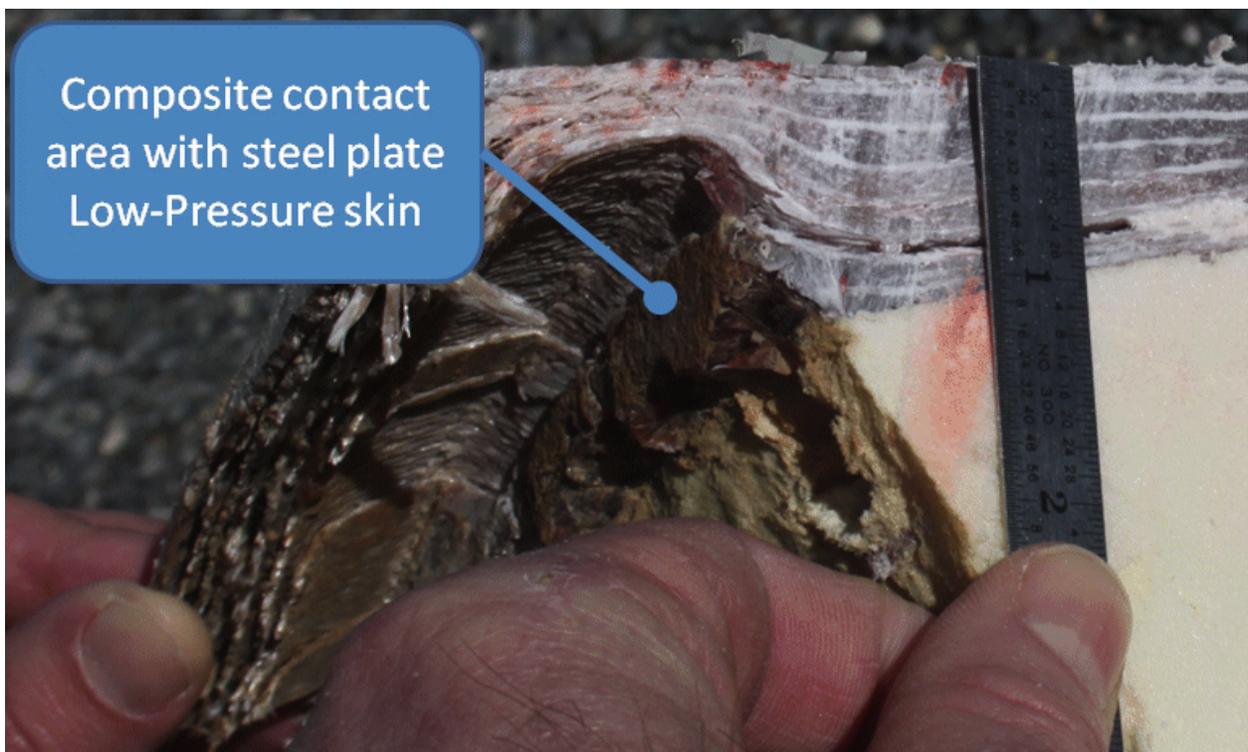
[Figure 18](#) shows the above section (Figure 17) from a slightly different angle. Note in this figure that there is a region of composite laminate that is bearing against the steel plate.

Figure 18. Contact area of composite against steel plate (steel plate missing)

- The embedded steel plate of the Knoeller blades was found to be in contact with the “compression” plies in areas on the low-pressure (compression) surface. This countered the Enertech assertion that the presence of the foam fillet was the sole cause of failure.

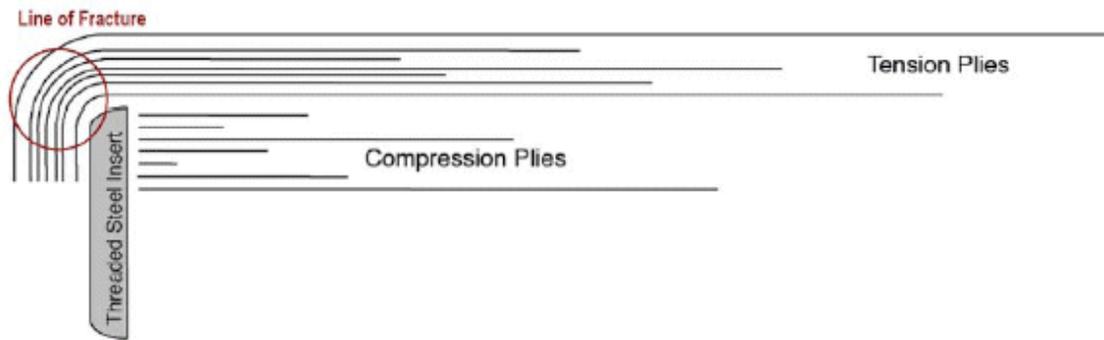
[Figure 19](#) indicates the location of the failure on the flange relative to the steel root plate. The fiberglass laminate at the blade root showed evidence of inter-laminar failure of the resin.

Figure 19. Location of blade failure in the laminate

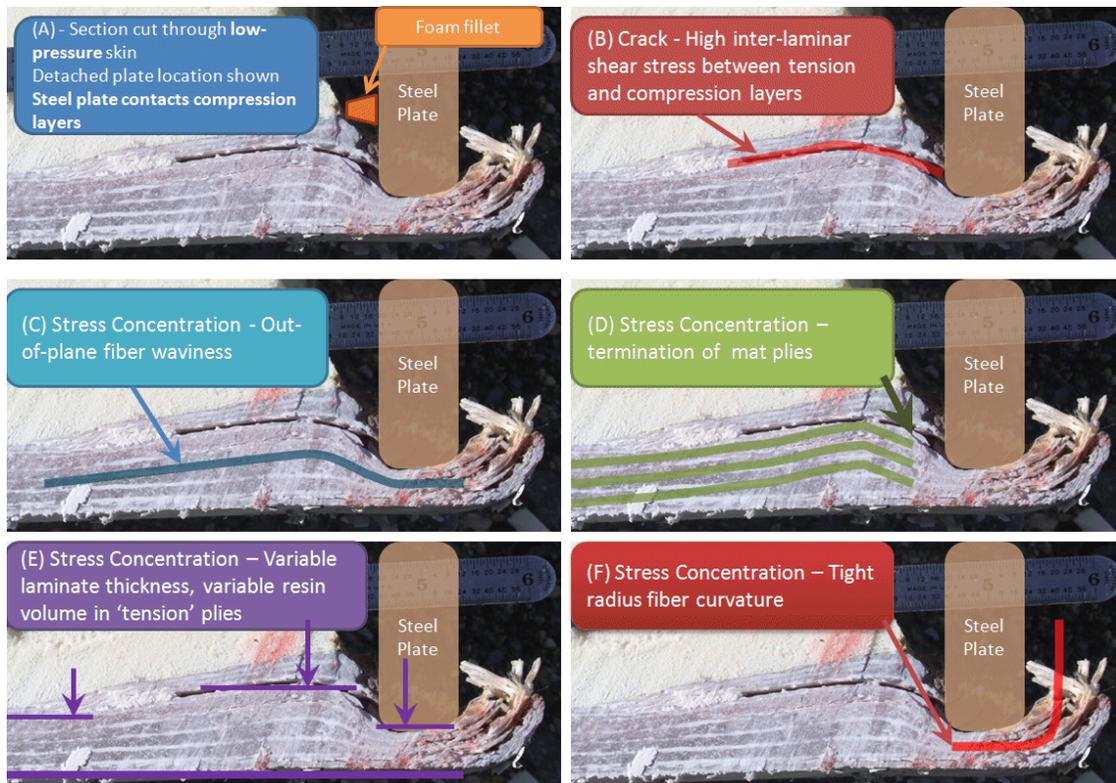
Figure 20 provides a description of stress concentration factors that are present in the root region of the unbolstered blade design. These stress concentrations would also be present in bolstered designs, however, the load path through the bolster would influence the effect of the stress concentrations on the composite structure.

Figure 20. Identification of stress concentrations in the root laminate

Each of the details shown in [Figure 20](#) are defects that could add significant stress concentrations (such as reducing nominal strength and fatigue lifetime) to the nominal performance of a given design. These defects are described as follows:

- **A crack between tension and compression plies.** The presence of this crack validates that there are significant inter-laminar shear stresses between the “tension” and “compression” plies. Without proper adhesion or through-thickness composite properties, this can be an area that is susceptible to damage due to the stress concentration at the termination of the “compression” fibers at the steel plate.

- **Variable laminate thickness.** Variations in laminate thickness can behave similarly to the laminate waves described above, with properties closer to the neat resin properties and stress concentrations caused by the changing fiber alignment.

- Post-mortem inspections of the failed blades at the Knoeller site revealed geometric and material stress concentrations in the highly stressed root region and included out-of-plane fiber waves, variable composite resin fraction, cracks between “tension” and “compression” plies in the laminate, tight-radius fiber curvature, laminate ply drops, and change in stiffness between steel and composite elements
