**Local Government Energy Program  
Energy Audit Final Report**

***Readington Department of Public Works Building  
287 Mountain Road, Whitehouse Station, NJ 08889***

***Project Number: LGEA53***

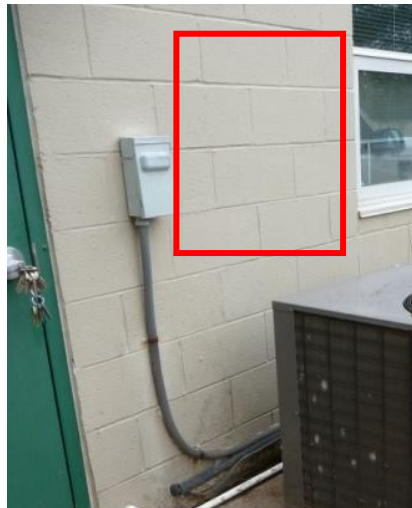
Exposed CMU blocks do not provide effective insulation in the office building

1. Replace corroded wall panel sections (mainly recorded in the front and in the corners of the garage)
2. Add insulation to exterior walls of office building. SWA suggests (with next major renovation) applying 2" XPS rigid foam boards to the exterior and covering it with preferred exterior finish.

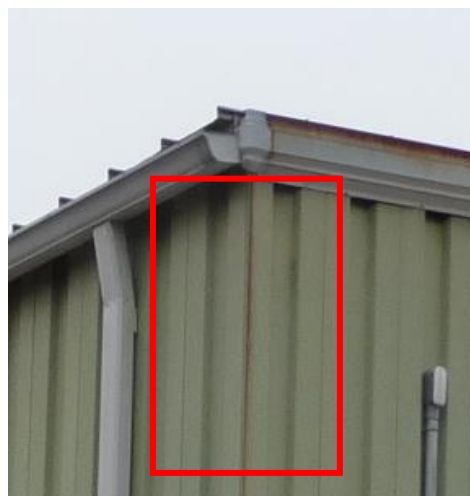
Corroded seams in wall due to rust

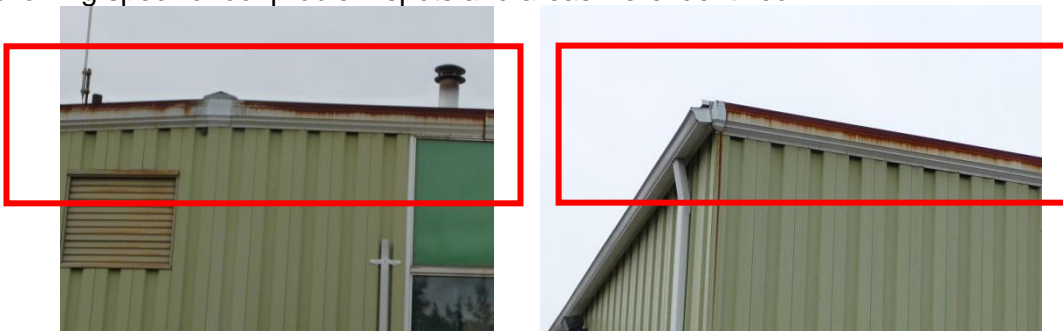
During the field audit, roofs, related flashing, gutters and downspouts were inspected. The main garage roof was found to be in poor condition, mainly attributed to rust corrosion, with signs of uncontrolled moisture leakage. Building management reported that the roof leaks. Visual evidence of rust and corrosion could be seen. The garage roof is close to the end of its useful life (30 years) and should be replaced. The office building has minimal amounts of thermal insulation and tape between seams of batt insulation is failing due to age causing additional air leakage through insulation.

Garage roof has rust damage attributed to uncontrolled moisture leakage and due to the metal roofing material approaching the end of its useful lifespan.

1. Unclog and maintain all roof drains/scuppers.
2. With next major renovation, replace standing seam metal roof due to age with new Energy star roof w/adequate insulation (SWA recommends R-30 minimum).

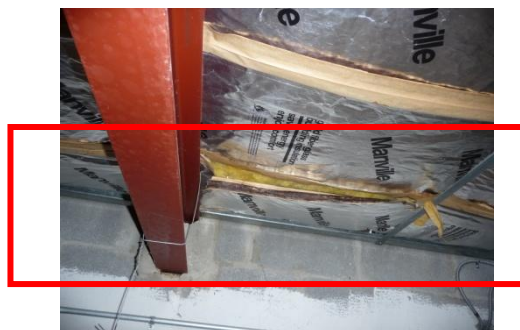
Office building contains minimal fiberglass batt insulation between metal studs, with failing tape at seams

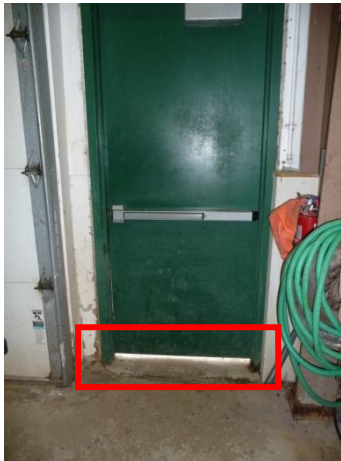
The doors were observed to be in good condition except for some missing or worn weather-stripping. SWA recommends checking the weather-stripping of each door (including garage doors) on a regular basis and replacing any broken seals immediately. Tight seals around the doors will help ensure that the building is kept continuously tight and insulated.

Light emitting through missing/worn weather stripping (typical at doors)

1. Install/replace/maintain weather stripping around all exterior doors.

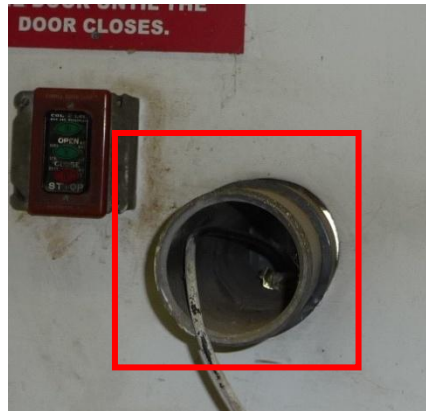
Oversized diameter hole with one wire running through none caulked and none insulated penetration (Typical improperly air-sealed penetration)

In addition to all the above mentioned findings, SWA recommends air sealing, caulking and/or insulating around all structural members, recessed lighting fixtures, electrical boxes and chimney walls that are part of or penetrate the exterior envelope and where air-leakage can occur.

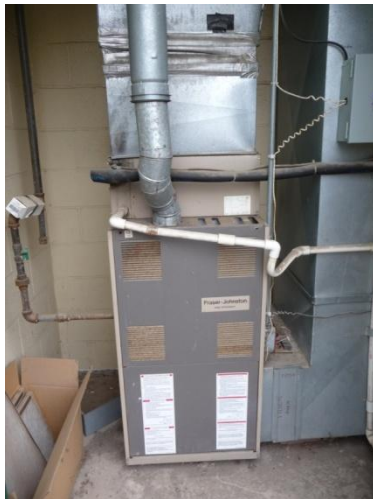
The front desk area and offices are heated with hot air provided by a gas fired 120,000 Btu/hr input, 80% efficient York Fraser Johnston furnace. All forced hot air is distributed via diffusers supported by the drop ceiling. There are two heating zones, each controlled by a programmable thermostat. There isn't any wall perimeter heating. The furnace is operating beyond its estimated useful life and breaks down often (roughly every 3 months). Office thermostats are set at 73 deg F during the day and 68 deg F on setback because the furnace often breaks down. SWA recommends that it is replaced with a condensing type furnace with 93% AFUE efficiency.

Office furnace;

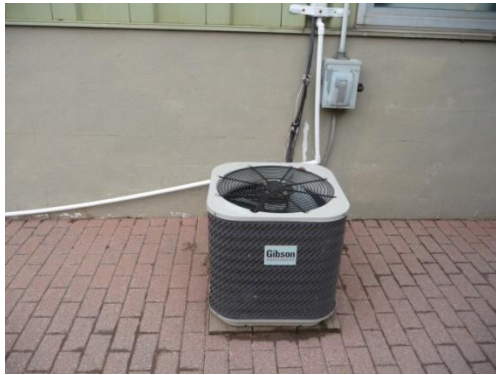
The Public Works Building cooling is provided by split systems, evaporator coils (located in the furnace discharge ductwork). These split systems' two (2) fan cooled outdoor condensers, are located behind the office building section at ground level. They use R-22 Freon for air cooling. Thermostat control issues are similar to those addressed in the above 2.4.1 Heating section. The Gibson – Nordyne condenser is associated with the break & locker room evaporator coil and has 70% estimated remaining useful life, however it is reported that it has not been operated in the last couple of years. The York condenser is associated with the offices evaporator coil and is operating beyond its estimated useful life. SWA recommends replacement with a high efficiency unit.

Break & Locker Rooms condenser

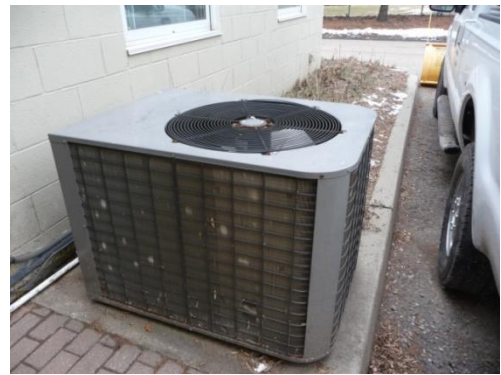
Office condenser

3	Replace (1) old office condenser - 5 Ton - SEER is 10.0 with new condenser - SEER 16	Energy Star purchasing and procurement site, similar projects	3,420	460	2,960	2,584	0.9	0	0.8	200	652	15	9,782	4.5	230	15	21	4,568	4,626
<b>Totals</b>			<b>4,509</b>	<b>520</b>	<b>3,989</b>	<b>4,795</b>	<b>1.7</b>	<b>0</b>	<b>1.5</b>	<b>270</b>	<b>1,109</b>	<b>-</b>	<b>14,708</b>	<b>3.6</b>	<b>269</b>	<b>-</b>	<b>26</b>	<b>7,518</b>	<b>8,585</b>

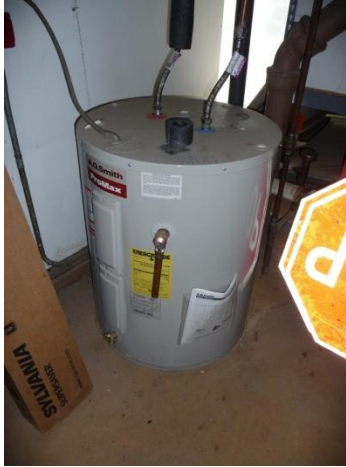
The domestic hot water (DHW) for the Readington Public Works building is provided by an AO Smith electric heater with 50 gal storage and 3,000 Watt upper / 3,000 Watt lower coils. This heater has 80% estimated useful operating life left and appears in satisfactory condition. It was reported that the purified well water is very hard and heaters generally last only a couple of years. Considerations should be given to replacing it with a high efficiency inline instantaneous condensing type gas fired heater without storage when it has reached the end of its operating life. Adding an incoming water purifier could also help increase the DHW heater longevity.

DHW electric heater
