**Local Government Energy Program
Energy Audit Final Report**

South River Rescue Squad Building
South River, NJ 08882

Project Number: LGEA48

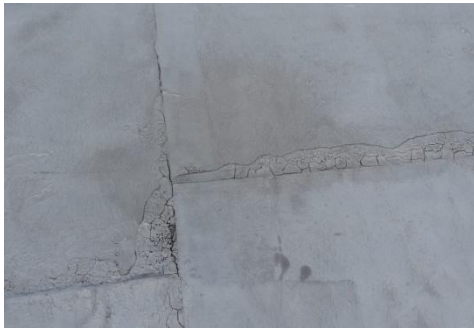
Delaminating / deteriorated roof membrane / patches.

1. Maintain / inspect all roof surfaces on a regular basis and repair / any deteriorated seams.
2. SWA recommends having the structural integrity of the roof evaluated, due to signs of deteriorating structural members and potential structural cracks found in the ceiling.

- Thoroughly and evenly insulate space above the ceiling and plug all ceiling penetration.
- Maintain roofs - SWA recommends regular maintenance to verify water is draining correctly. Maintain / inspect all roof surfaces on a regular basis and repair / any deteriorated seams.

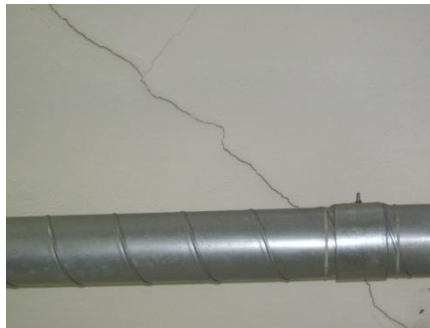
Cracked gypsum wallboard visible in the interior.

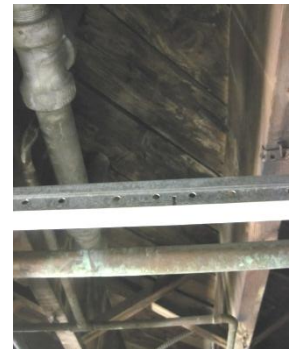
Deteriorating roof decking discovered.

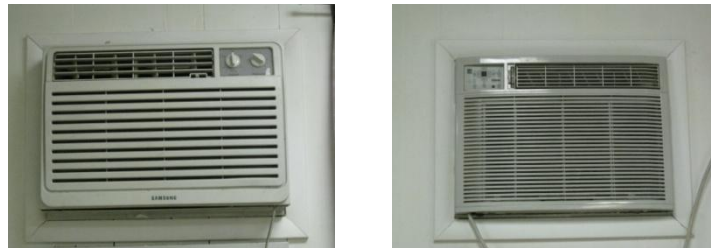
Air-leakage at sleeved window / wall air-conditioning units

1. Openings around window air conditioning units need airtight gaskets / sealants for optimal all year performance. Insulated hoods should be installed during winter months if removing the units is not an option.

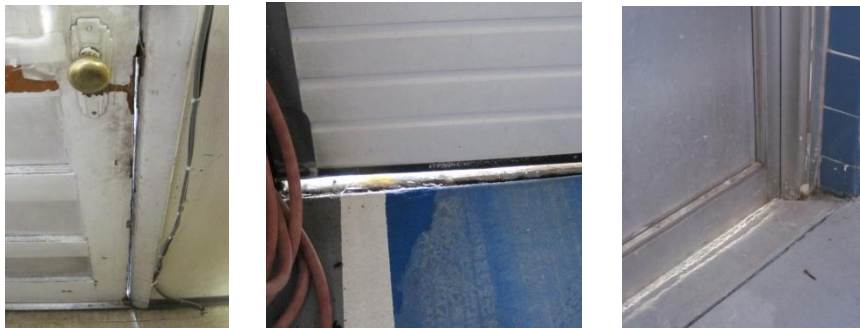
Missing / worn weather stripping at swing and overhead type doors

1. Install / replace / maintain weather stripping around all exterior doors.

- Provide weather stripping / air sealing - SWA observed that exterior door weather-stripping in places was beginning to deteriorate. Doors and vestibules should be observed annually for deficient weather-stripping and replaced as needed. The perimeter of all window frames should also be regularly inspected and any missing or deteriorated caulking should be re-caulked to provide an unbroken seal around the window frames. Any other accessible gaps or penetrations in the thermal envelope penetrations should also be sealed with caulk or spray foam. Openings around window air conditioning units need airtight gaskets / sealants for optimal all year performance. Insulated hoods should be installed during winter months if removing the units is not an option.

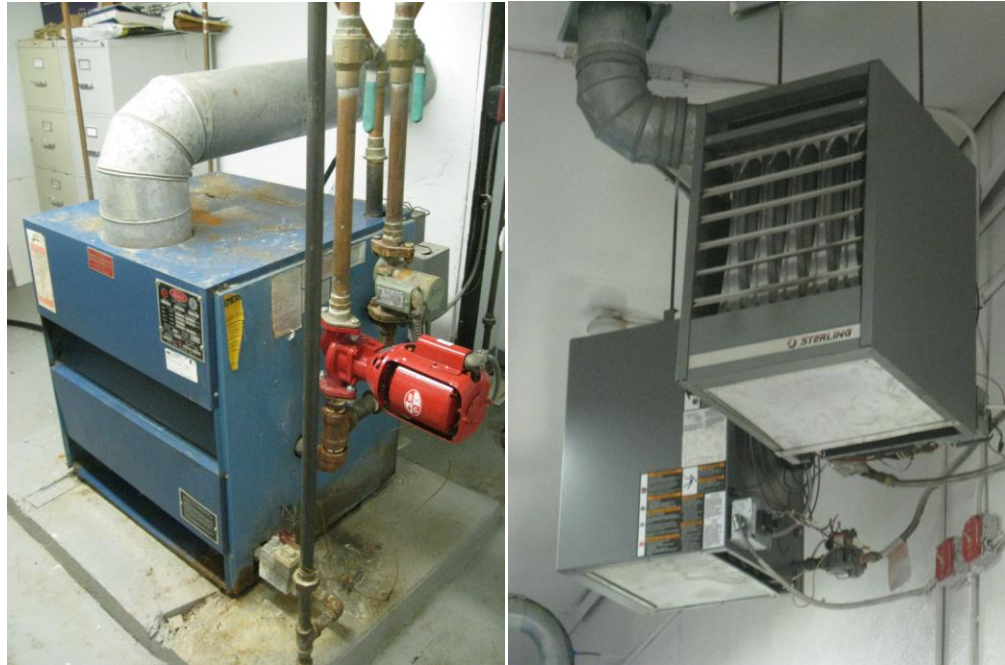
The building is heated via hot water circulated by two (2) pumps to various terminal units throughout the first floor. The heating hot water is produced by one (1) fire-tube style hot water boiler located in the boiler room on the basement level. The Utica natural gas fired boiler was installed in 1980 and has surpassed its expected service life of 25 years per 2007 ASHRAE HVAC Applications Handbook. The boiler burner is rated for 300 MBtu/hr input and 240 MBtu/hr output for an estimated efficiency of 80%.

30-year old hot water Utica boiler; ceiling hung gas fired Sterling van / truck bay heaters

There weren't many complaints about the ability of the heating system to provide adequate comfort to the building occupants. SWA recommends that the existing boiler be replaced with two fully condensing hot water boilers with pulse combustion burners. The boiler size should be specified to more closely match the actual heating load of the building. The boiler should be managed by one (1) controller that controls the firing rate to ensure maximum efficiency at all times.

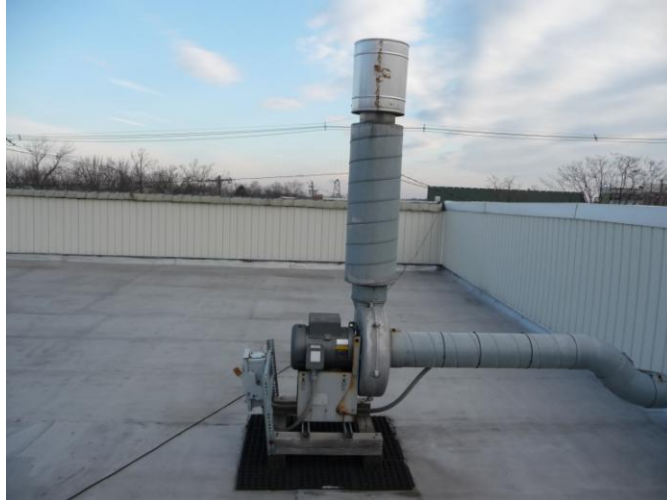
Rooftop van / truck exhaust fan

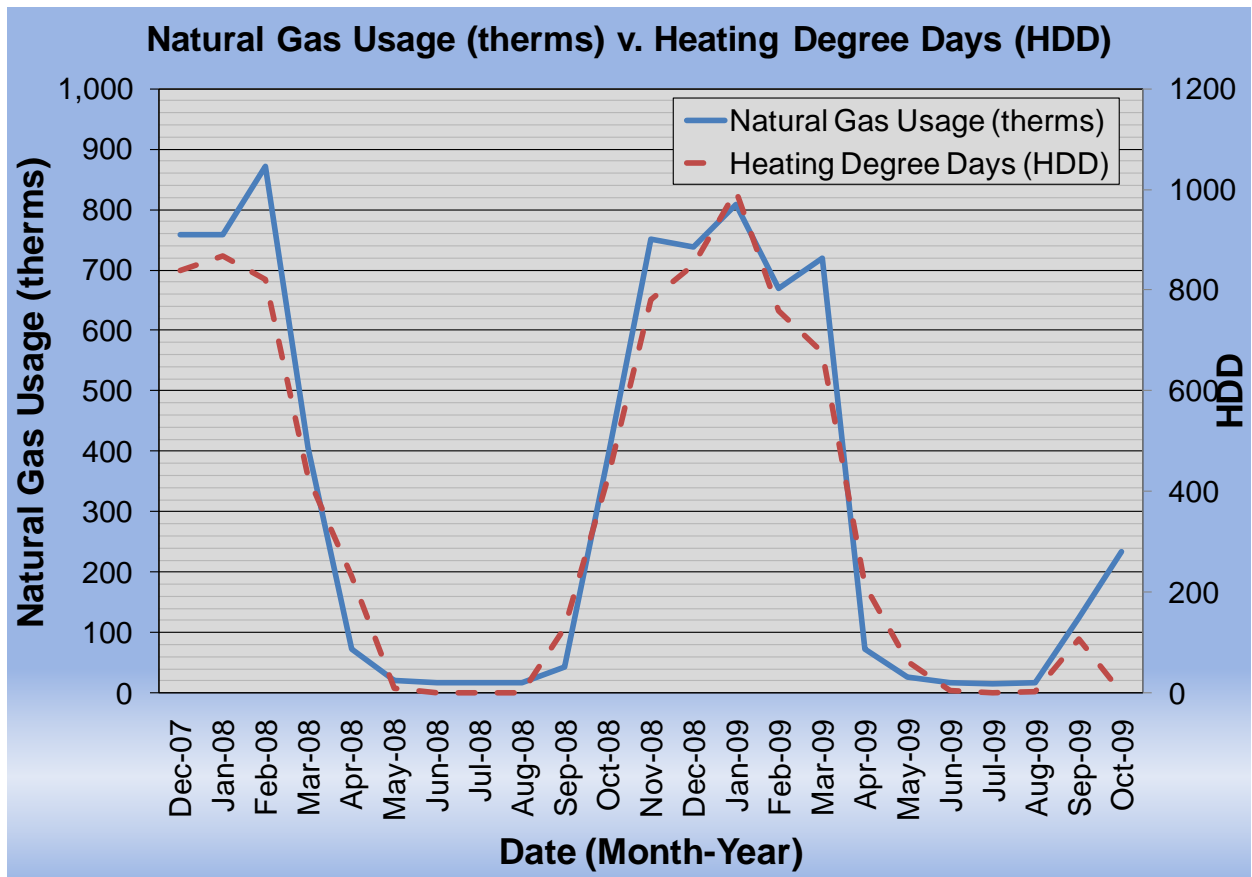
The following is a chart of the natural gas load profile for the building, peaking in the coldest months of the year and a chart showing natural gas consumption following the “heating degree days” curve. Some utility bills have more than one month estimated and combined.
