**Local Government Energy Program
Energy audit report**

***Union County Educational Services Commission (UCESC)
Crossroads School & Administrative Offices
45 Cardinal Dr
Westfield, NJ 07090***

Project Number: LGEA17

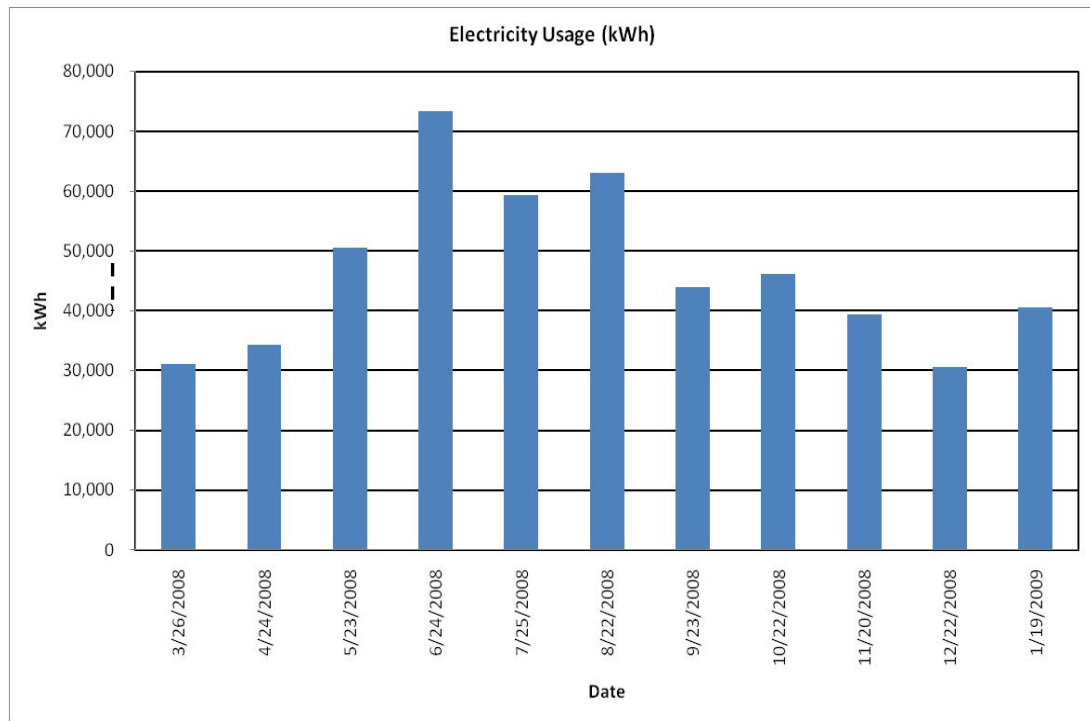
The following chart shows electricity usage for the UCESC Building based on utility bills for the 2008-2009 billing period.

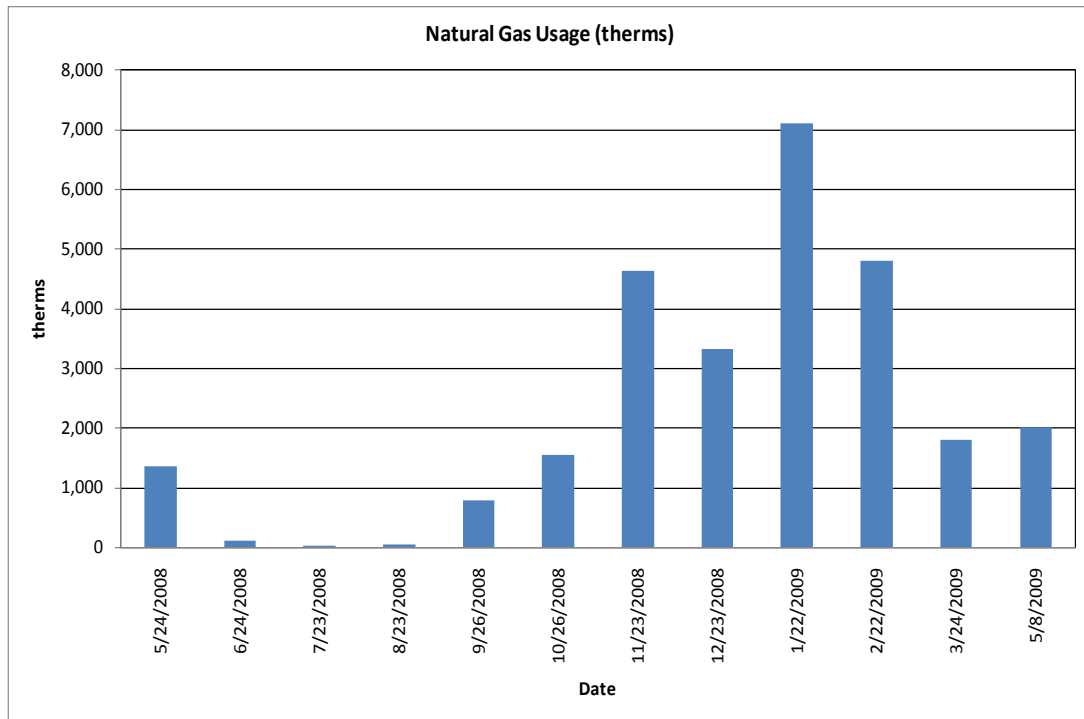
The following chart shows the natural gas usage for the UCESC Building based on utility bills for the year March 2008 to March 2009.

In the above chart, the natural gas usage follows a heating trend as expected. During the summer it is clear that the natural gas usage is very minimal which reflects that heat is not being used and the DHW load is minimal.

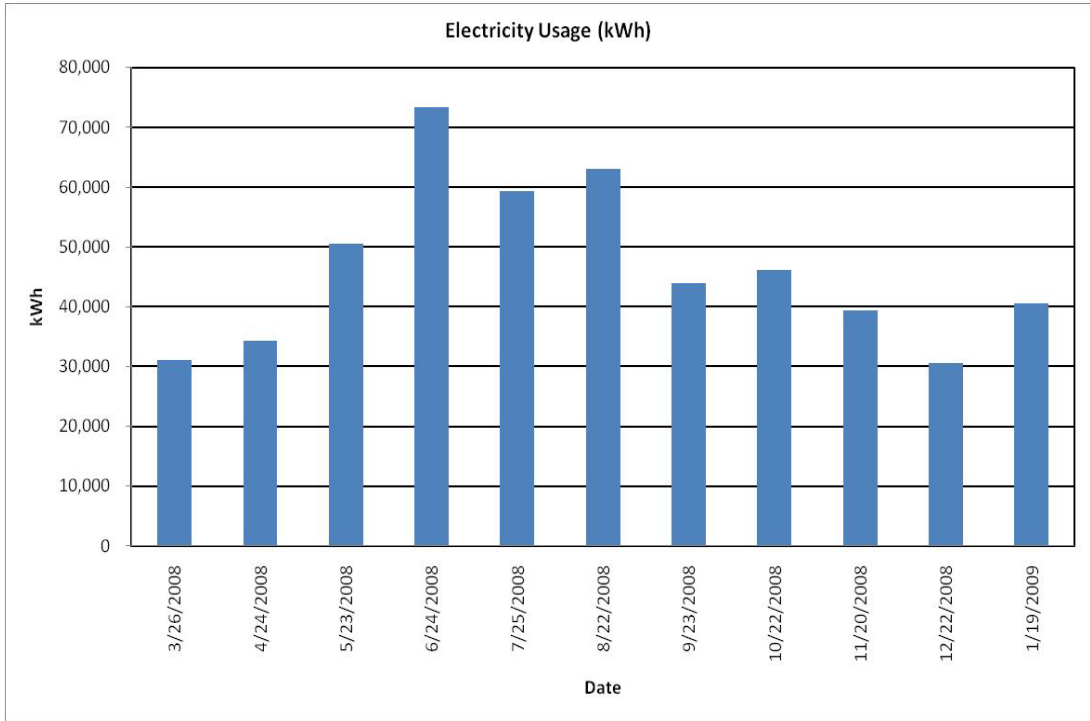
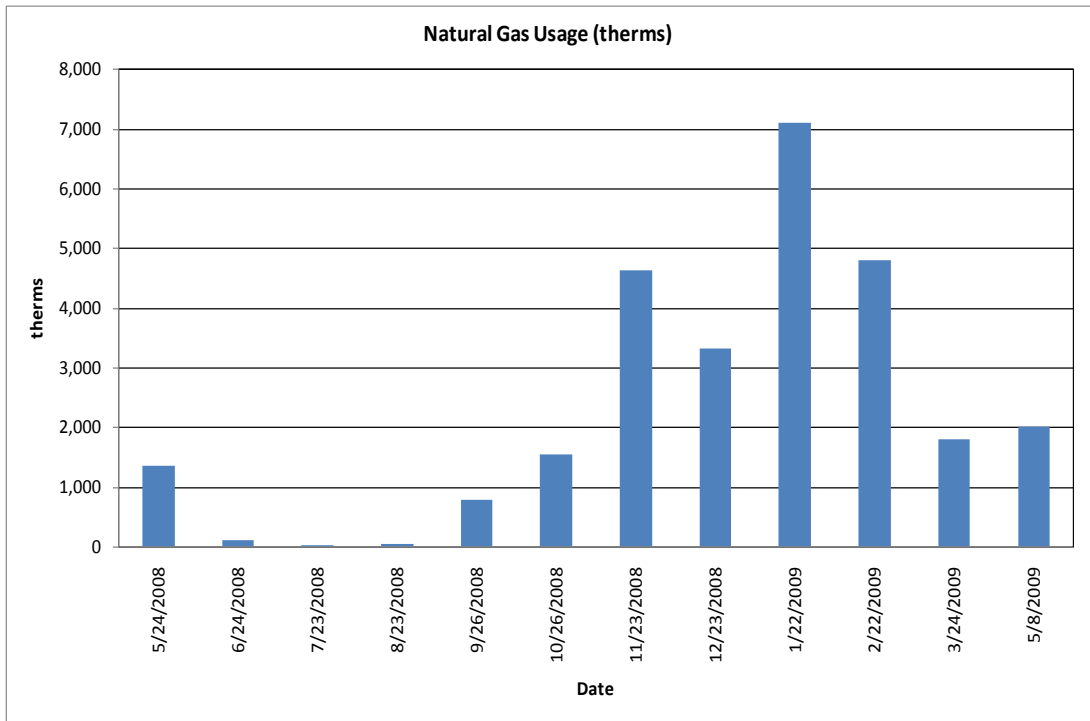
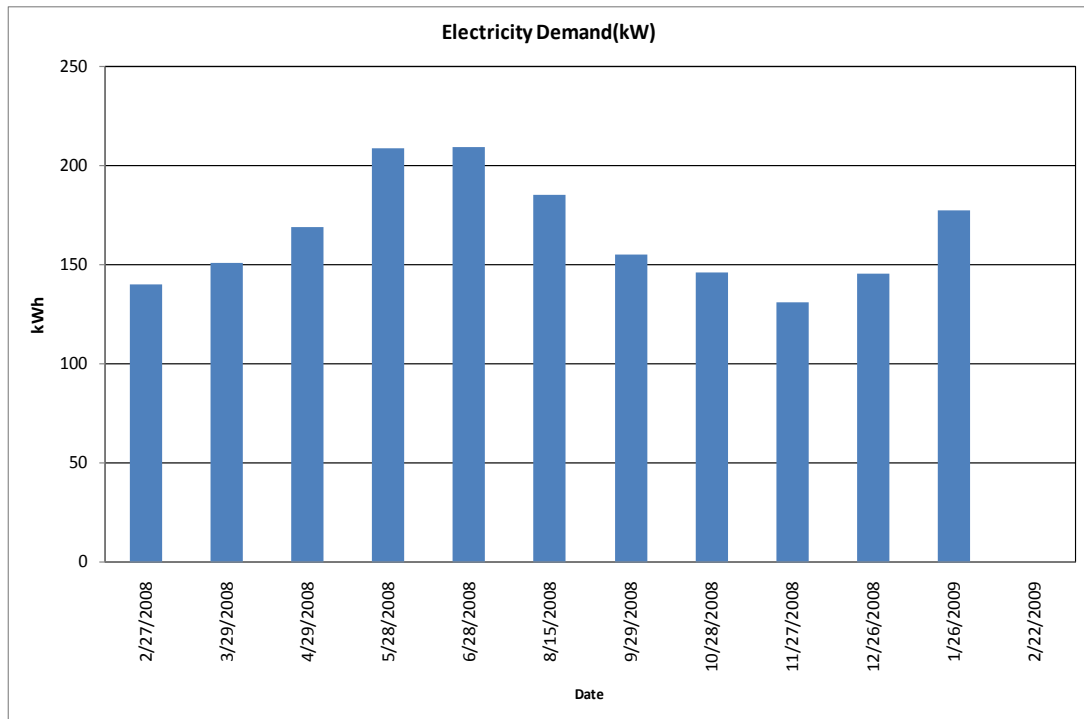
The average electrical peak demand for the previous year was 161.6 kW and the maximum peak demand was 209.6 kW. The electric and gas load profiles for this project are presented in the following charts. The first chart shows electric demand (in kW) for the previous 12 months and the other two charts show electric and gas usage (in kWh), respectively.

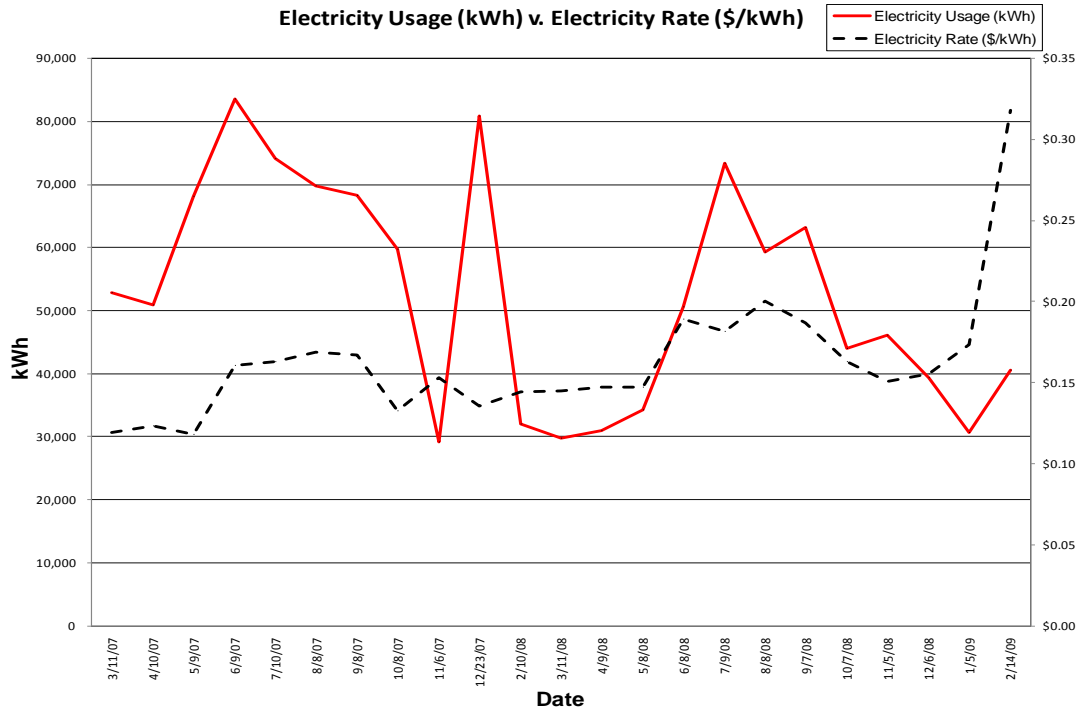
Electricity prices reflect electricity usage

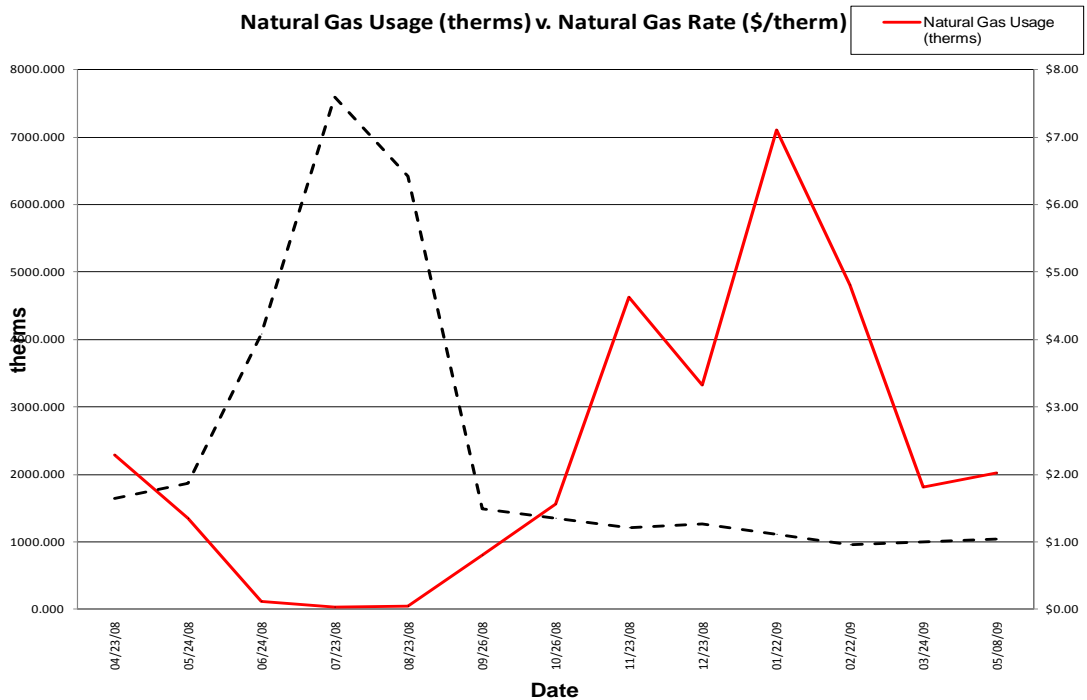
Natural gas prices fluctuate as expected with usage
