Executive Summary

This report covers the investigation of the Enertech E44A wind turbine incident at the Knoeller site. The objectives of the investigation were to determine the cause of the turbine's failure and whether it was an isolated incident or a potential problem that would reoccur in existing and new E44A wind turbines. This report provides background information and a description of the events, actions, documentation, and assessment process. In addition, the report describes the site evaluation and design and testing assessments and provides conclusions and recommendations.

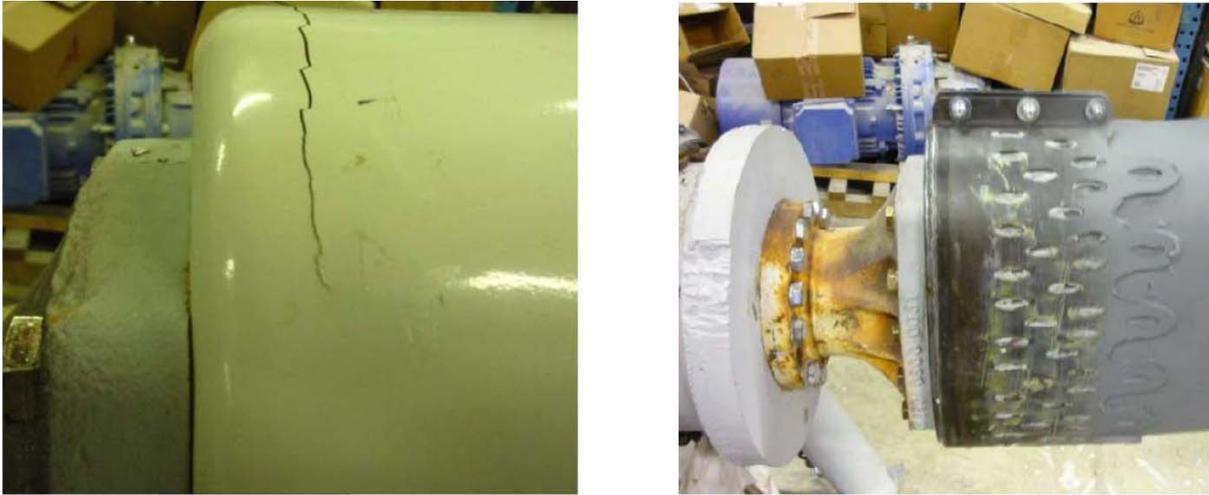
Figure 2. Unbolstered (left) and bolstered (right) root designs

- **Rev A (Knoeller Blade)**—Baseline design that failed on the turbine installed at the Knoeller site. Also referred to as the “unbolstered” blade.
- **Rev B (Martin Blade)**—Replacement blade used at the Martin site, also referred to as the “bolstered” blade. The Martin blade was modified from the Knoeller design by adding a welded steel structure, or bolster, and incorporating changes in the root laminate schedule. Rev B (unbolstered) refers to a future blade design where the bolster would not be installed.

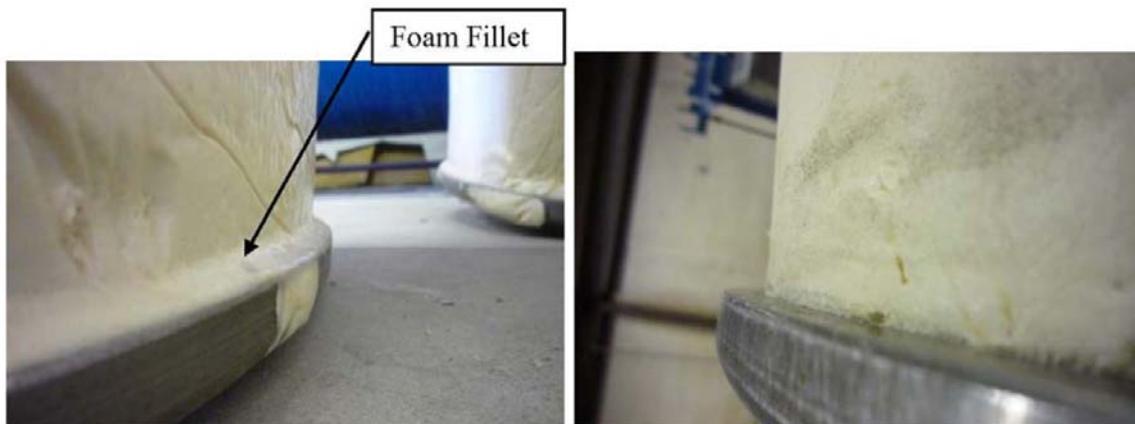
Figure 4. Root plate and foam core with (left) and without (right) the fillet

The Enertech Analysis Document provides an overview of the blade manufacturing process. During an internal audit, Enertech considered several possible causes of blade failure and concluded that the presence of a foam fillet, which was not removed during the manufacturing process, caused the premature failure of the blades. [Figure 4](#) shows the root steel plate and foam core with and without the fillet.

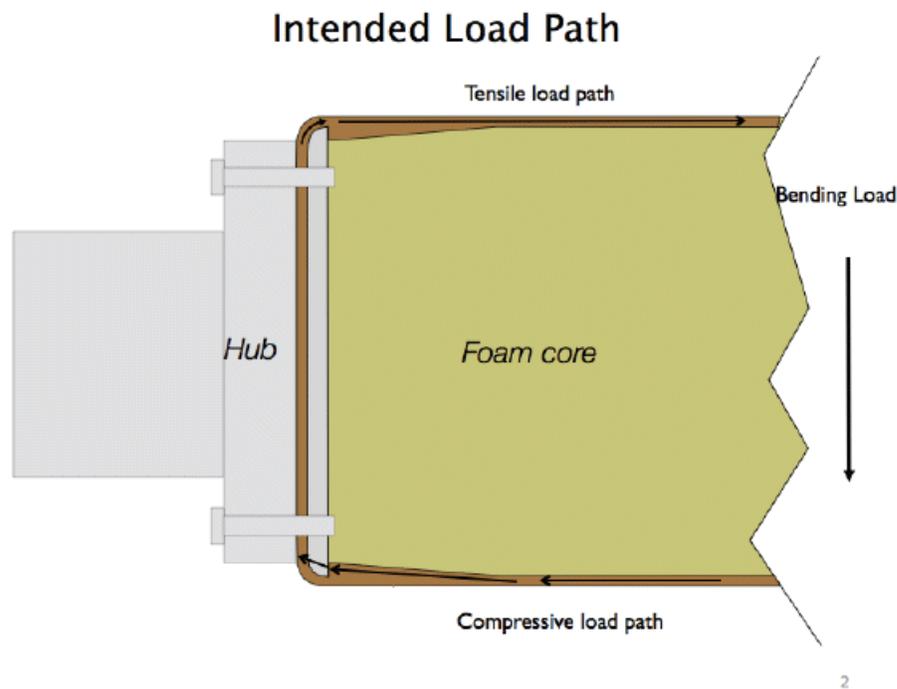
Figure 6. Enertech-stated load path in the root region

Figure 5 provides a schematic of the design intent, showing the laminate schedule and a representation of tension and compression plies. Figure 6 provides a schematic on how loads are designed to be carried in the root laminate and steel root plate.

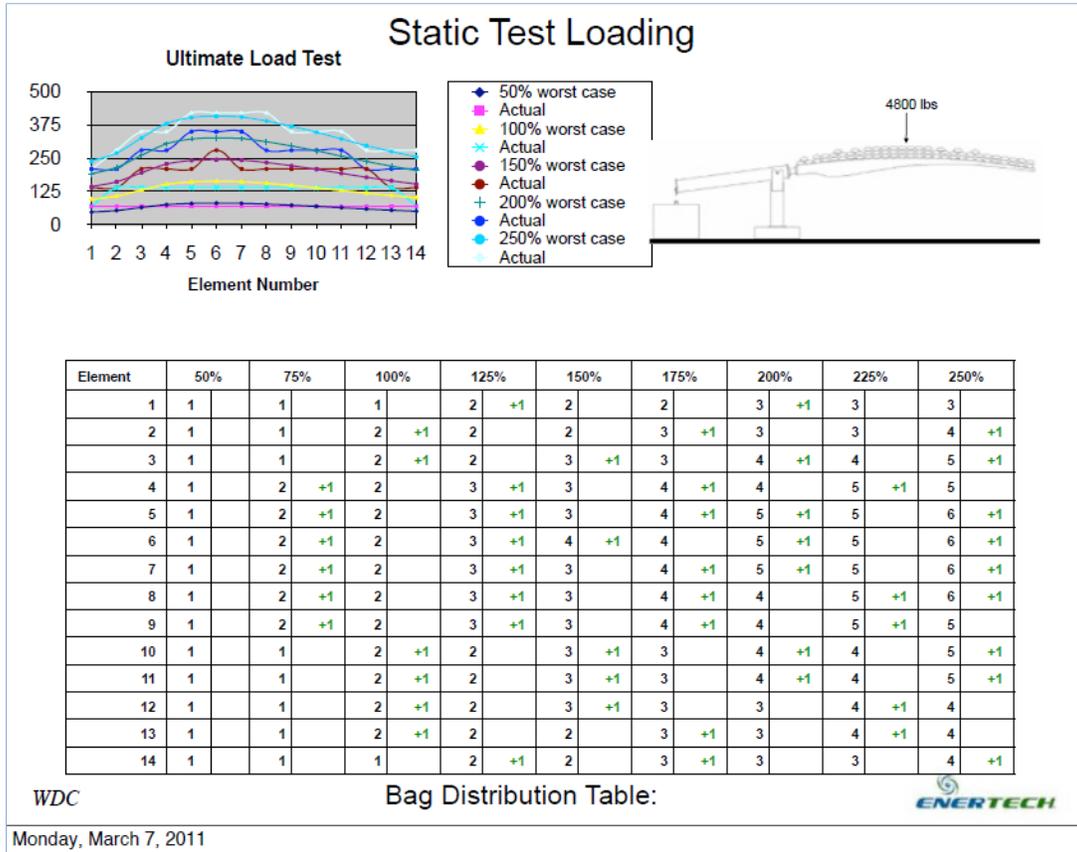
Figure 8. Static load distribution

[Figure 8](#) provides the static loading details included in the Enertech Presentation and provides the sand bag distribution used for loading the blade at increasing load levels. The information includes the distribution of the test load, as applied through the weight of sand bags, and provides the total weight applied by the sandbags: -4,800 lbs near mid-span. The total load applied (4,800 lbs) matches the weight distribution shown in the graphic in the upper left for 68 sand bags, which is consistent with the Enertech-stated 250% level in the tabular information.

Figure 8 (from the Enertech Presentation) provides basic information on the load magnitudes applied by Enertech during the static loading. The total static test load shown (4,800 lbs), compared to the bag distribution for the 250% of 68 bags, resulted in a per-bag weight of 70.6 lbs. A root-bending moment of 50,188 ft-lb was obtained by using the information in the bag distribution table for the Enertech-stated 250% load. [Appendix A](#) provides the analysis for this calculation. The weight of the blade added an additional moment to the total applied test root moment. Using an assumed blade weight of 325 lbs, with a center of gravity at 8.5 ft from the root of the blade, resulted in a root moment of 2,763-ft lbs. The total applied root moment during the static test would be the sum of bag weights and blade weight moment. For the Enertech-stated 250% target loading, the root moment would be $50,188 + 2,763 = 52,951$ ft-lb (71.8 kN-m). While the weight and center of gravity was estimated, differences between estimated and actual values would have a very small effect on the analysis that follows.

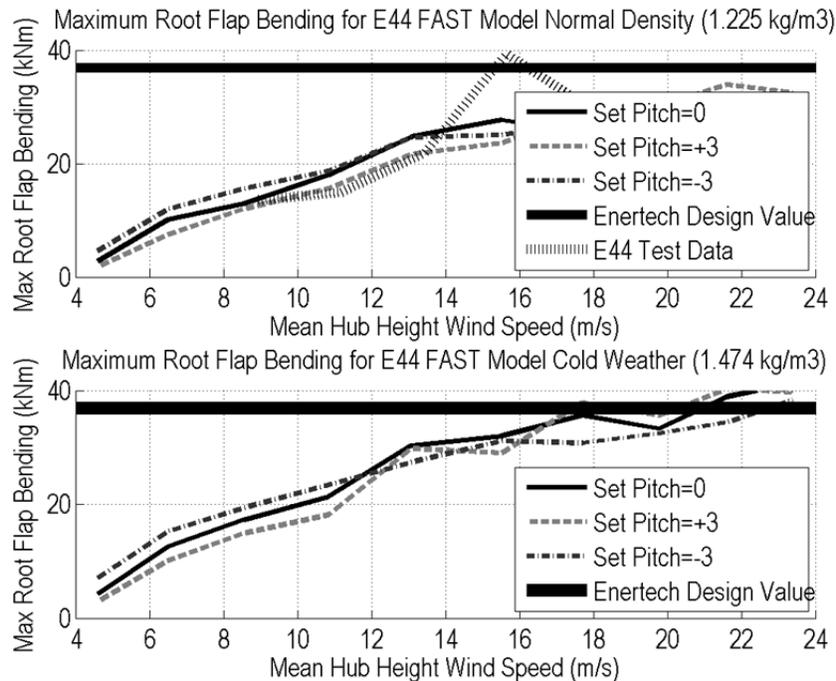
Figure 15. Maximum root flap-wise moment as a function of wind speed under standard and high air density conditions

[Figure 15](#) compares bending curves at different densities and pitch settings. Note the influence of air density on the loads. The Enertech design value is also shown.

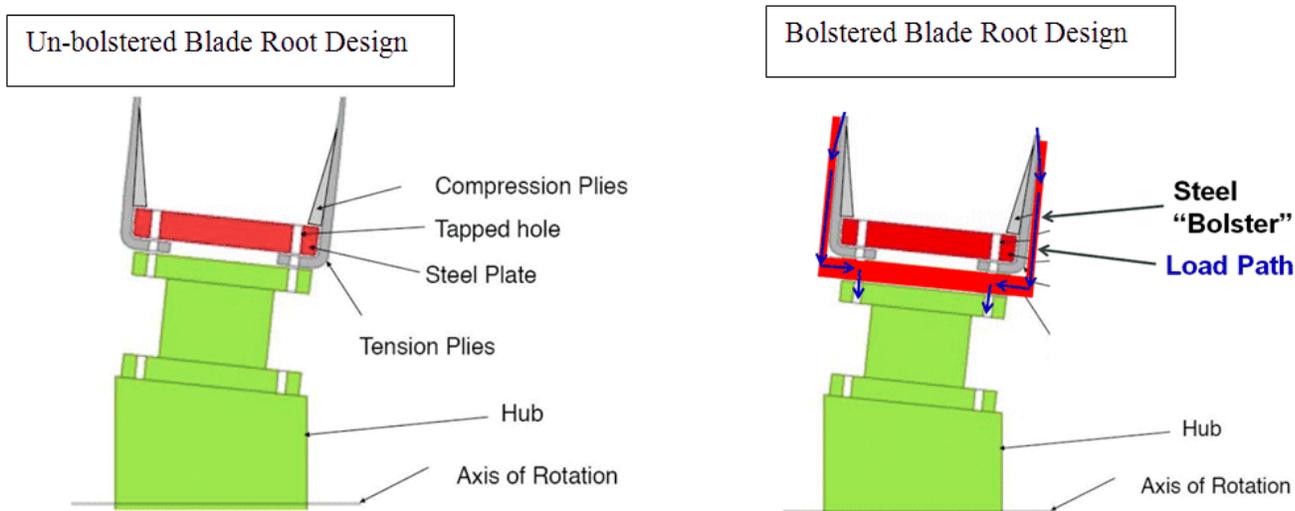
Figure 21. Unbolstered (left) and bolstered (right) designs

Wetzel Engineering performed a design assessment of the blades and included detailed information in the Wetzel Report. This assessment was the most comprehensive analysis possible, given the level of detail provided by Enertech. Enertech supplied only high-level documentation on the design and manufacture of the blade and included basic descriptions of laminate schedules, a one-page manufacturing plan, and material (not structural composite) data sheets from material suppliers (these documents are identified in the Wetzel Report). Load information came from the basic summary information from the Enertech Analysis document and the Enertech Load Summary document. Substantial additional documentation detailing loads, design, and manufacturing assurance would have been necessary to conduct an assessment to demonstrate conformity with standard design practices or compliance with relevant standards. The Wetzel Report used the available information to assess the Rev A (unbolstered) and Rev B (bolstered) designs. [Figure 21](#) provides a schematic of the load path and general design intent between the unbolstered and bolstered designs.

The results of both the Wetzel Engineering characteristic Rev A and Rev B models indicated that nominal stress and strain levels were high compared to standard design practices. The Wetzel models represented an ideal structure. Decreases in strength and fatigue performance of the as-manufactured blades would be expected, as the presence of stress risers within the laminate (noted in [Figure 20](#)) were not considered in the Wetzel model. The characteristic Rev B bolstered design indicated very high stress levels in the adhesive bond that holds the bolster to the fiberglass shell. The stress levels modeled in the adhesive bond would exceed the accepted Germanischer Lloyd (certification body) level of 1,000-psi, which would be the stress level used for certification in the absence of test data.
